Oil Dilution on Jaguar Land Rover D8 diesel SUVs

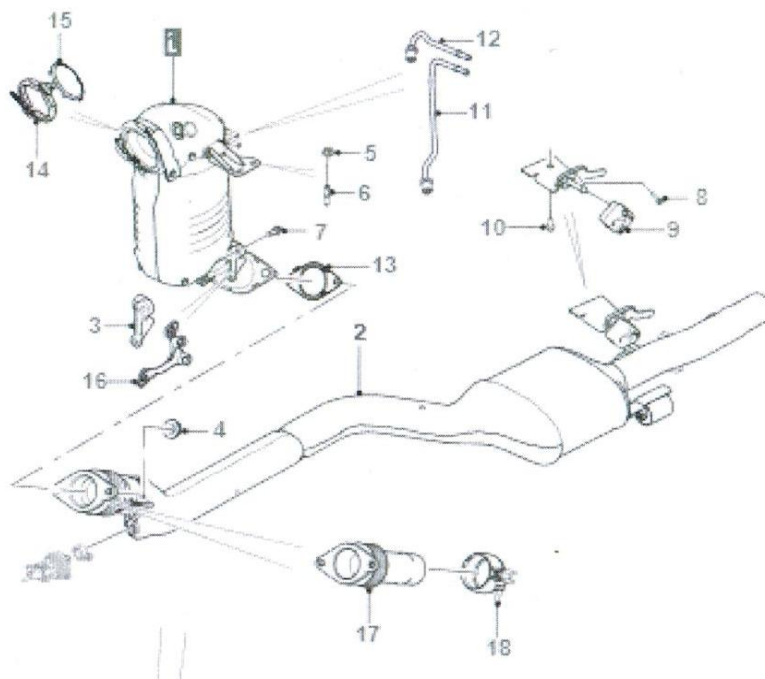
Fig 1 – Jaguar XE Exhaust

In the Jaguar XE parts schematic below the combined DOC-DPF is the vertical canister (1) which attaches to the Ingenium turbo outlet by clamp (14) and seal (15). DEF injection is made at bottom left under clamp (18) and the SCR consists of the horizontal pipe and canister (2).

The Jaguar XE X760 went on sale with this exhaust hardware and architecture in early 2015. The first sales recorded for the Jaguar XE were March (2), April (20) and May (624). The next vehicles scheduled to receive the Ingenium engine with EU6-compliant exhaust emissions after-treatment (mandatory for all new vehicles sold from 1st September 2015) would be the Discovery Sport L550 and Range Rover Evoque L538. Until August 2015 these cars were still being sold with a transversely-mounted EU5-compliant PSA/Ford Duratorq 2.2L diesel engine.

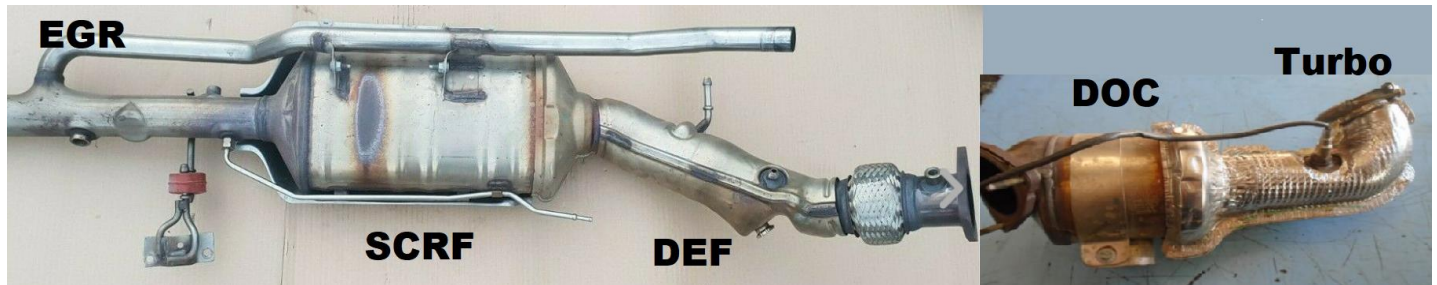
Fig 2 Discovery Sport / Range Rover Evoque Exhaust

The D8 chassis forward bulkhead prevented JLR from fitting a “close-coupled” exhaust like the schematic shown above in Fig 1 for the Jaguar XE X760. In the [letter to sales staff](#) JLR admitted that there were “*some engineering challenges with the current layout of the architecture, affecting the proximity of the heat source (engine) to the filter and so its ability to complete the burn off of the soot in the particulate filter*”. This refers to cooling effects caused by the additional pipework between the turbo outlet, DOC and SCR.

On the Discovery Sport L550 and Range Rover Evoque L538 the SCR is too far back from the engine for passive regeneration to occur during normal driving. According to Johnson Matthey a SCR-based filter performs less passive regeneration than a catalyzed soot filter (CSF) at a given temperature while an active regeneration of SCR takes more than 50% longer to complete ([Scientific paper 2016](#) / [Presentation](#)). The performance of this after-treatment system is impaired by a number of operational constraints and consequences which can be summarised as follows:

The first reason for lack of passive regeneration is the physical architecture of the exhaust after-treatment system. As shown by the photographs above (**Fig 2**), on the Discovery Sport L550 the DPF is separated from the turbo outlet by two lengths of pipework (total distance 70 cm) which creates an effective heat sink. The SCRF therefore operates at a much cooler temperature than a close-coupled CSF-type DPF attached to the turbo outlet, as on the Jaguar XE X760.

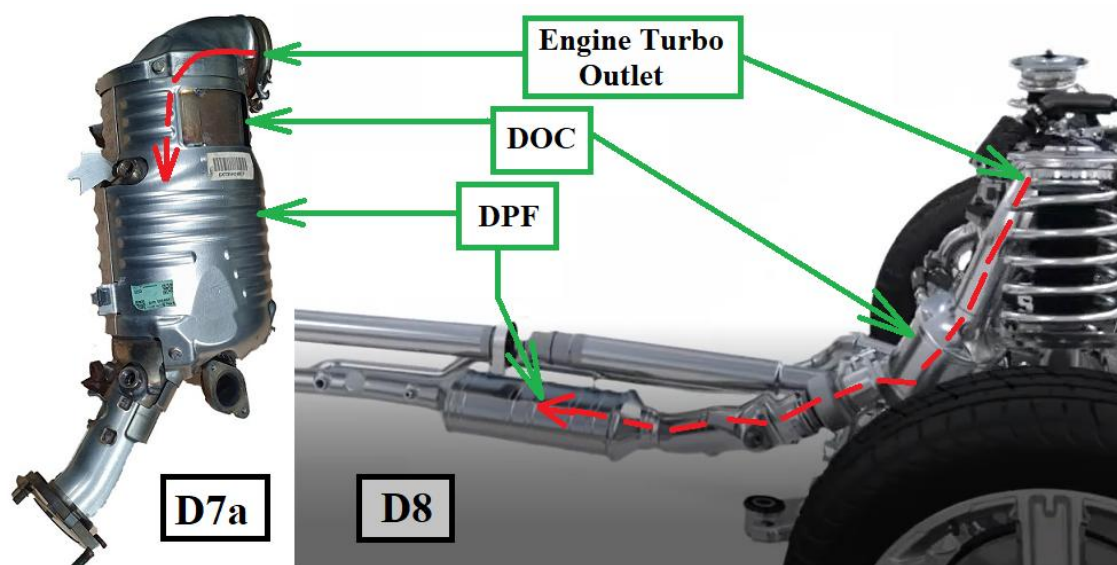
Fig 3.

Jaguar Land Rover exhaust after-treatment architectures

The Jaguar XE oxidation catalyst and DPF are physically contained within a single canister so that virtually no heat loss occurs between the engine and the DPF. The DPF temperature remains high at all times and it requires very little additional heat to reach the temperature required for active regeneration to begin. On the D8 architecture there are two lengths of pipework separating the turbo outlet from the DOC and the DPF so heat losses are significant. The D8 vehicles require longer periods of active regeneration to heat up the DPF and maintain the temperatures required for active regeneration to continue. This is what is meant in JLRP00100 where it says that “*the duration / distance to complete a full regeneration on 2.0L diesel Evoque / Discovery Sport is longer than on 2.0L diesel Jaguar XE*”.

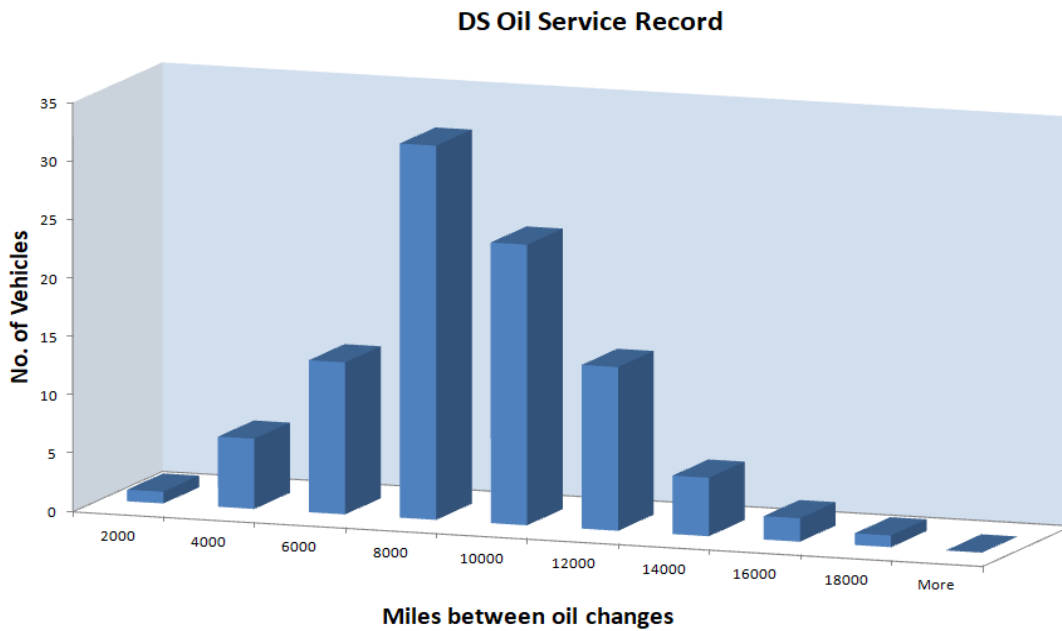
Details of almost 100 early oil changes reported on the DS forum between July 2016 and January 2019 were collated and the data published on 12th March 2019. The average mileage before an oil change was required was [8,306](#), or 39.4% of the nominal service interval.

Fig 6. Engine oil change interval due to dilution – Discovery Sport L550.
